Perform Guard No. 6012

Subject: Testing Update

Boron-treated expanded polystyrene insulation resists native subterranean termite damage after 3-year field exposure

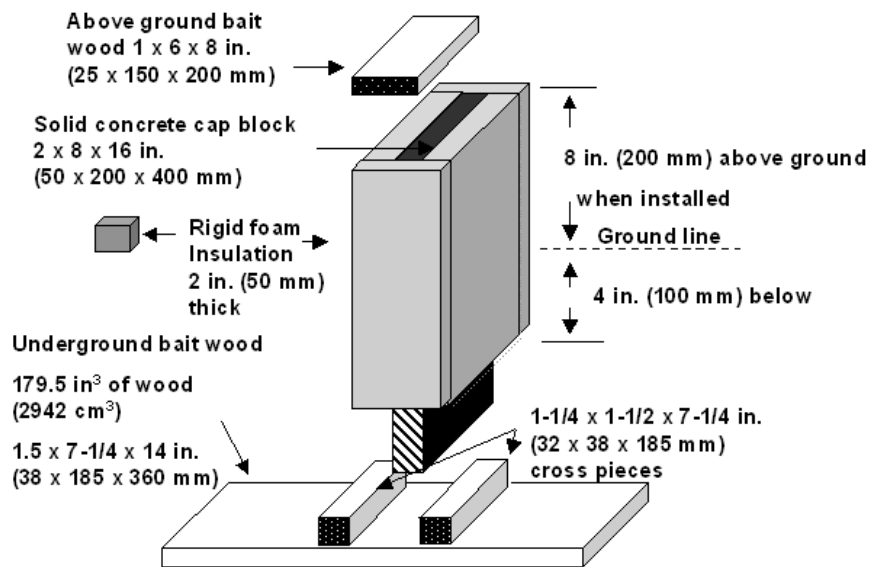
Figure 1. — Schematic showing construction and installation details of test unit used to field test rigid foam insulation with untreated aboveground and below-ground baitwood pieces to attract termites. Each insulation piece was bonded to concrete or insulation with a continuous layer of untreated or borate-treated construction sealant.

Test units. — A test unit was a solid concrete cap block with 12 inches (300 mm) of EPS bonded flush with one end of the block on all four surfaces by a continuous layer of either treated or untreated CS. **Figure 1** shows the components and how a unit was installed. Installation was completed by an opaque plastic cover that provided protection from weather and the dark conditions that termites prefer for tunneling activities. A 3/8-inch- (10-mm-) diameter hole in each narrow face provided ventilation to reduce condensate moisture. A southern pine sapwood stake, 3/4 by 1-1/2 by

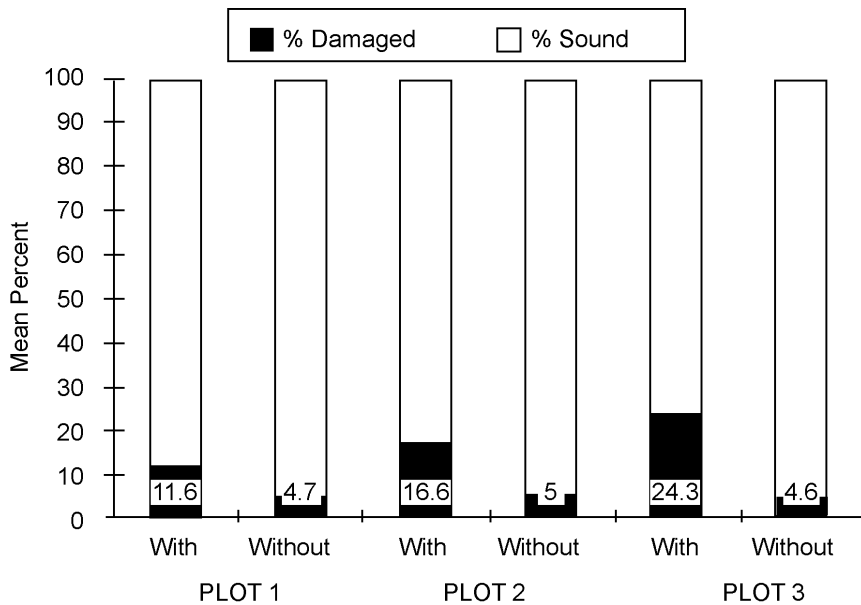
Figure 2. — Mean percent sound and damaged expanded polystyrene in samples with and without visible termite damage from each of three plots when images were analyzed following 3 years of field exposure.

Characteristics. — For 720 analyzed images, 375 had visible termite damage, 345 did not. Estimates of damage including apparent damage from CS and/or identification labels for the 375 samples ranged from 11.6 to 24.3 percent, by plot (Fig. 2). For the 345 images without visible termite damage, the mean (\pm standard deviation) estimated damage was 4.8 ± 1.8 percent. This error factor

associated with image analyses was essentially the same for each plot (Fig. 2).

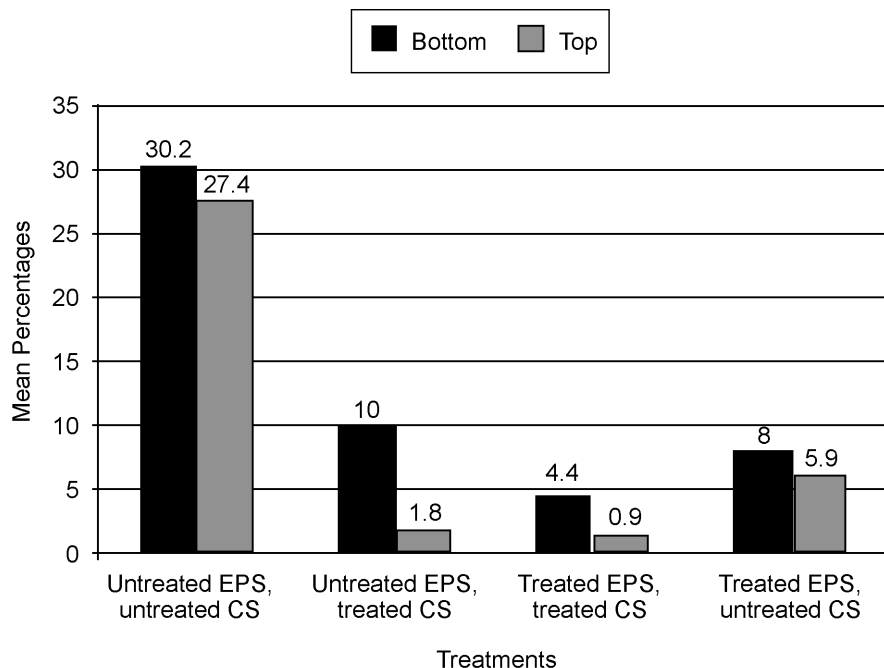
Figure 3. — Mean percentages of termite-damaged insulation per treatment for bottom and top samples of units in all plots after 3 years of field exposure ($n = 60$). Means shown are after subtraction of an error factor associated with image analyses of 2.7 for bottom and 3.4 for top samples: n for error factors = 28 and 145, respectively.

Analysis was conducted to compare the damage to the top part of samples with that in the lower or bottom part of the sample. Damage to the top region would indicate significant tunneling throughout the EPS. Mean percentages of damage for all plots were always higher for bottom samples than top samples for all treatments (Fig. 3). This was true across all plots and in each plot. For untreated EPS and untreated CS, damage was 30.2 percent for top samples and 27.4 percent for bottom samples. However, damage was 0.9 percent for top samples and 4.4 percent for bottom samples from units with treated EPS and treated CS, indicating that termites were only making exploratory attacks at the bottom of treated EPS pieces adjacent to the large underground baitwood. When

only EPS or CS was treated, damage to top samples was from 8.0 to 10.0 percent and damage to bottom samples was from 1.8 to 5.9 percent (Fig. 3).
